BEKER INDUSTRIES CORP.

Subject: PRODUCT LOSS FROM NO. 3 GYPSUM POND

Subject: GYP POND DIKE FAILURE

LOG OF EVENTS REGARDING GYP POND DIKE FAILURE

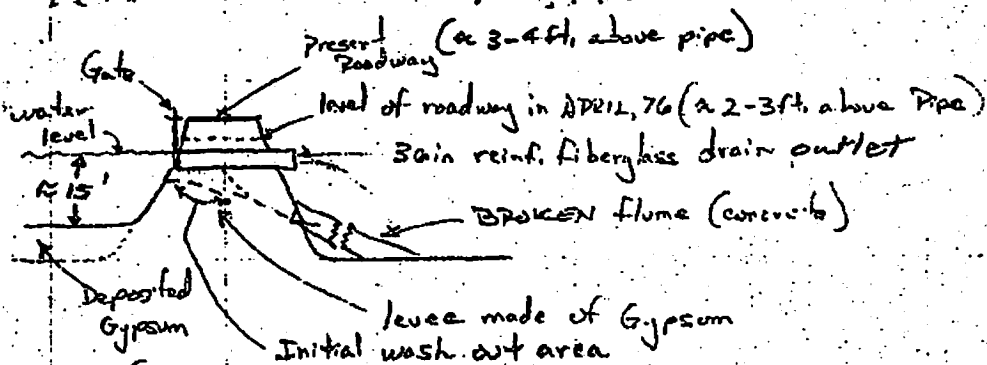
Workmen, building up the dike on Gypsum Pond No. 3 noticed no sign of leakage Monday afternoon. However, Tuesday, March 2, they noticed leakage about 7:15 a.m. at Gypsum Pond No. 3 south section drain outlet and notified superiors who arrived at the leak about 7:45 a.m. The 36 in. diameter drain outlet pipe (reinforced fiberglass) was suspended partially in mid air due to severe wash out under the pipe by a stream of water. Two bulldozers pushed Gypsum and two 20 ton haul trucks dumped rock 4 in. and larger for about 5½ hours (8:00 a.m. - 1:30 p.m.) to block the leak. Plywood sheets, plastic liner, and other fill materials were also used but could not stop the leak, about 1:30 p.m., a 15 ft. wide by 15 ft. deep section broke loose releasing the contents of the pond.

The failure was caused by a leakage around the drain outlet which quickly eroded away the Gypsum fill material and grew more quickly than could be filled.

NOTE: Bottom of pond is 10 mil PVC plastic liner & side walls have 8 mil polyester reinforced coated pvc liner.

(How Situation Appeared at 8:00 A.M. Tues. March 2, 1976)
Per. description & sketch by C. WHITING, Proj. Engr.
SIDE VIEW or cross section looking east.

TOP or PLAN VIEW (as described by G. L. DANNIS, Acid Suppl.)

NOTE: NO DRAWINGS OF THE PIPE SUPPORTS & Details of liner seal at drain could be found at the plant.

1. The new overflow system should be designed to minimize the chances of leakage around the area of the new drain pipe.
2. The repair work on Gypsum Pond No. 3 (south) should be expedited as much as practical so business interruption will be minimized should Gypsum Pond No. 2 develop a leak.

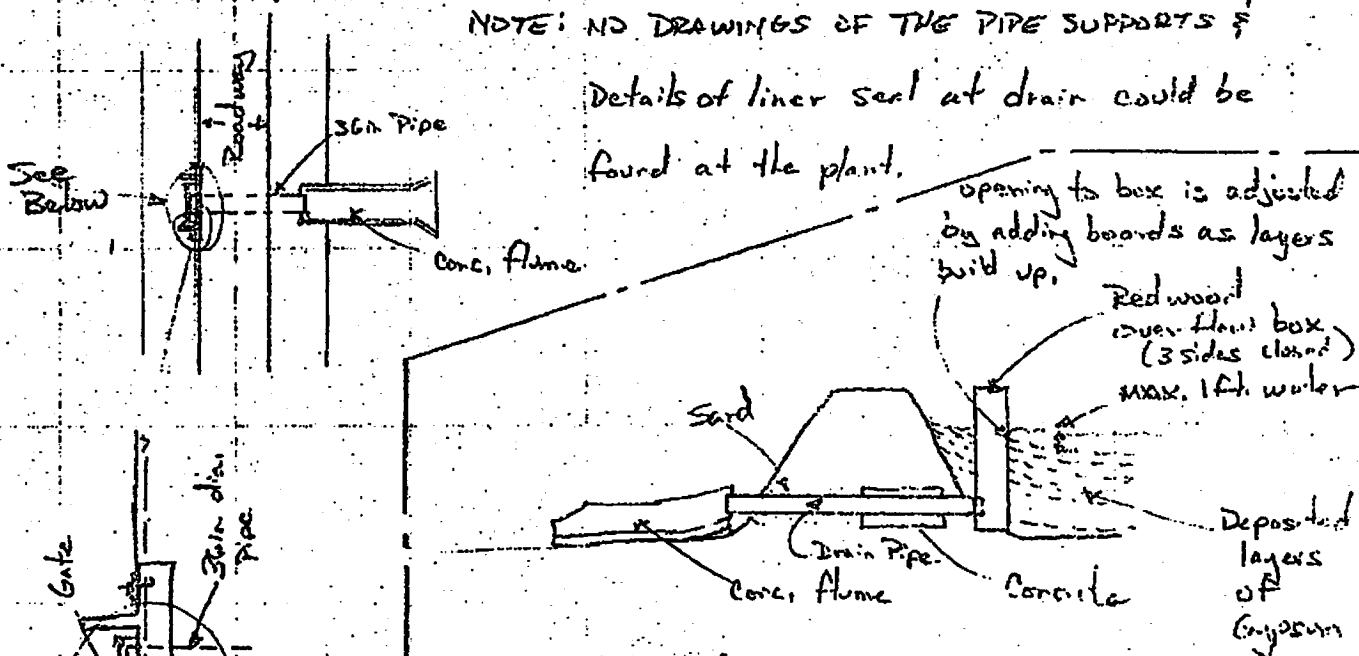
General features of proposed new overflow system presently in planning stage.
